Red Eléctrica and Birdlife:
15 years of applied research

RED ELÉCTRICA DE ESPAÑA

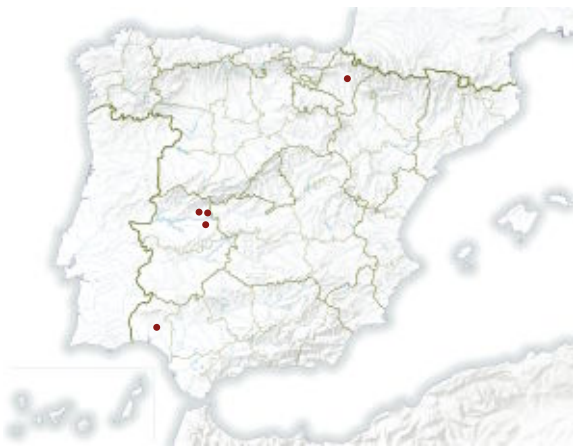
• Areas in which the collisions of birds with electrical lines were studied in the ERP project

Between 1992 and 1993, within the framework of the ERP project, more than 30 km of electrical transmission lines were examined regularly: Valdecaballeros-Almaraz/Morata, Almaraz-Guadame, Foz de Lumbier, Cáceres-Trujillo (Llanos de Cáceres) and a distribution line in the Marshlands of Odiel (Huelva), located in different points of Andalusia, Extremadura and Navarre. The same sections were examined on seven occasions, to estimate the death rate along the sections under study and identify the species most affected, and the factors related to this. The following results were obtained:

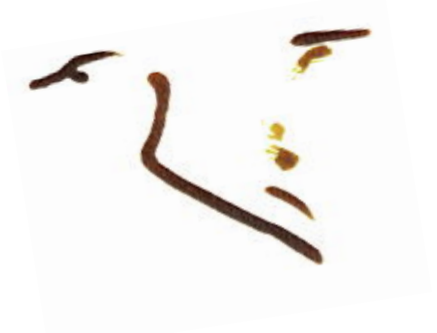
Oversized eagle (70 cm x 120 cm)

The tests performed were sufficiently conclusive regarding the efficacy of the models as an anti-collision method: none of them affected the behaviour of the birds in flight, to such an extent that the idea of using them to reduce the rate of accidents with electrical lines was considered. However, there was a qualitative difference between the model types tested: the most realistic model, representing an oversized eagle, caused certain reactions in some groups of birds, in particular birds of prey, but unfortunately this did not lead to a change in their behaviour in flight that might have determined less risk of collision. On the contrary, the other models tested, flat silhouettes of a bird in flight and a perching bird caused hardly any reaction among the birds, and some birds of prey even perched on the pylon itself, next to the model.

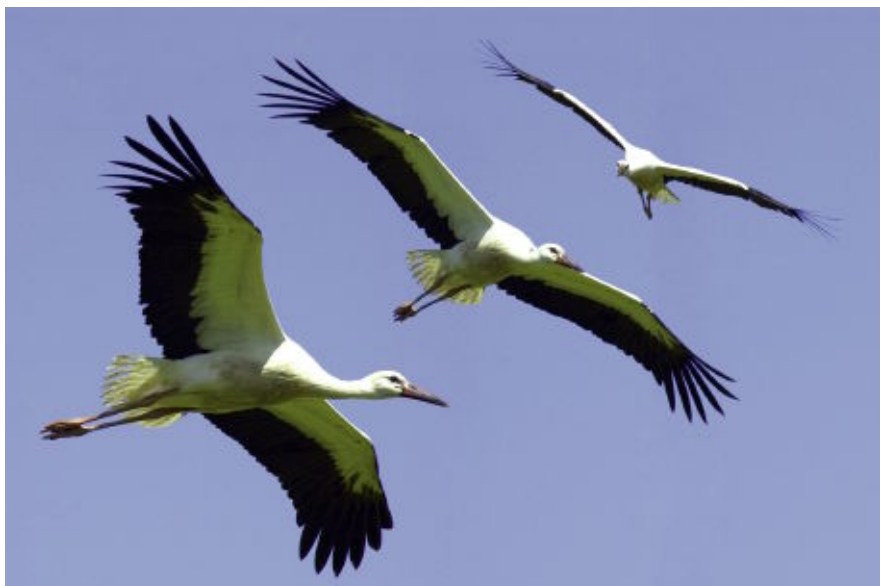
*Anti-nesting devices
Consisting of differing numbers of rods (with a length of 60 cm, and thickness of 2 cm) and smaller rods (with a length of 1 m, and thickness of 6 mm) laid out in different directions*

The anti-nesting devices installed are formed by different configurations of T-shaped rods. The option of savings in materials is taken into account, and every effort is made to reduce the difficulties caused in the facilities by the work of the operators on the pylons.

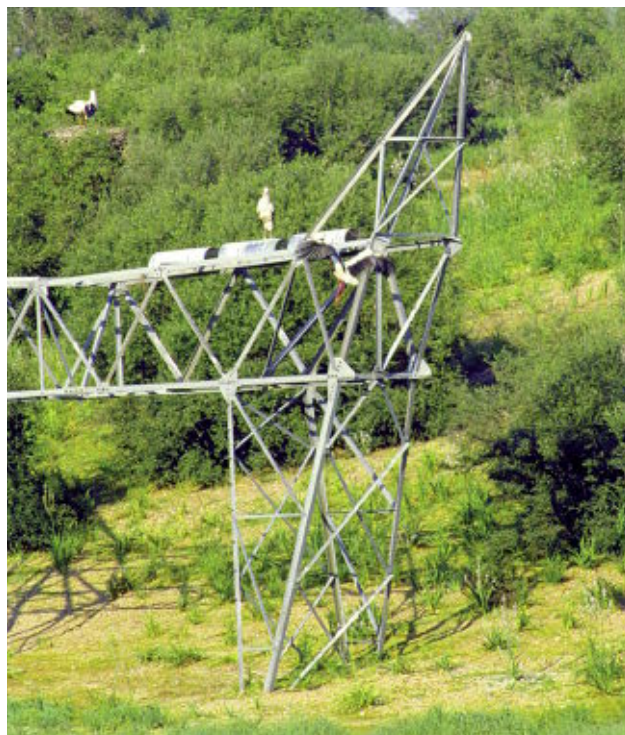
In 1998 a test support was constructed with a cat-head design near the Almaraz-Guadame line, whose pylons have the same characteristics. In turn, two metal structures were erected, similar to the cat-head type pylons next to a breeding colony of storks in la Dehesa de Abajo (Puebla del Río, Seville); the largest colony of this species nesting in trees in the Iberian Peninsula. These structures, together with the initiation of the project, formed an enormous natural laboratory for studying the interactions between the nesting storks and the electrical lines.

Vertical plate

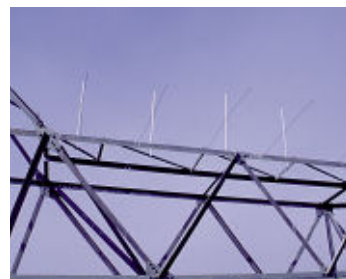
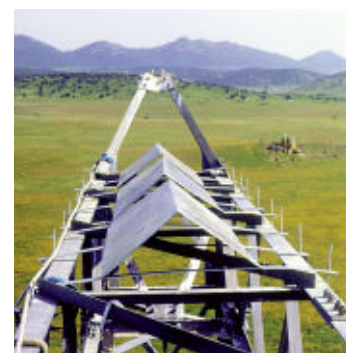
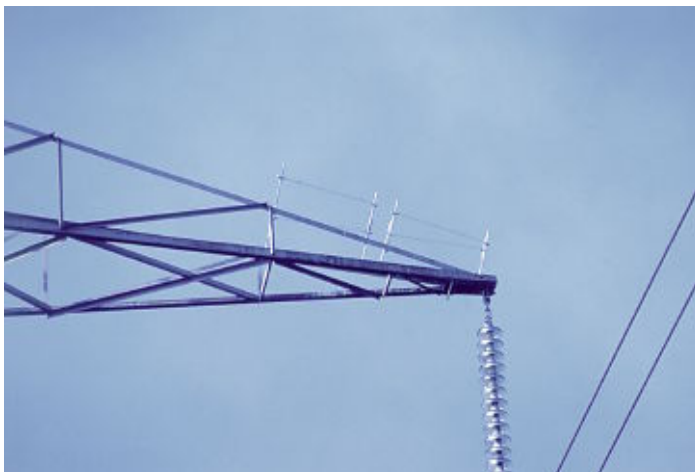
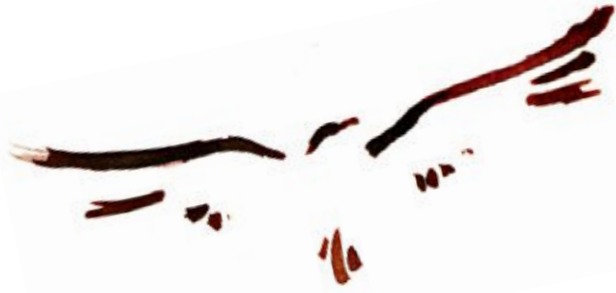
Based on the latest tests, Red Eléctrica has been completing and adapting the installation on sections of line with nesting problems. Annual monitoring is being carried out on the installation of anti-

nesting devices in order to record the problems and make new proposals to correct problems arising during installation and complete it in pylons that have not yet been modified or in which new breeding points have been generated.

The sections included in this field study have 3 basic designs: the cat-head type, double-circuit type and layer type. The anti-nesting measures have varied with respect to previous years.

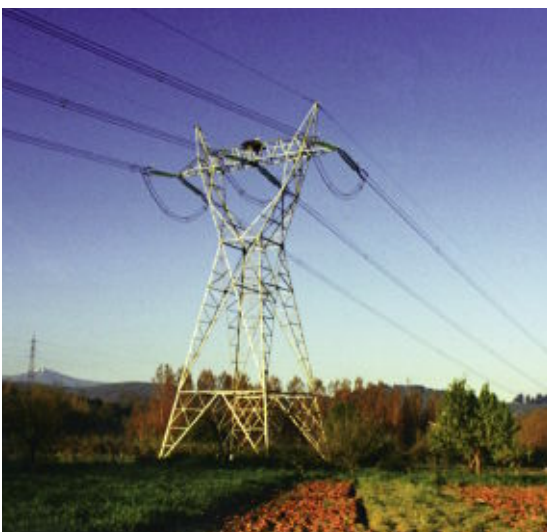
There are 6 basic pylons designs, with the following parts that can be modified using anti-nesting methods (the number of areas is shown between brackets):

- > Cat-head type: bridges (1), half crosspieces (2) and tower (2)
- > Layer-type: bridges (1), half crosspieces (2) and tower (2)
- > Double-circuit, three-crosspiece type: half cross pieces (8)
- > Double-circuit type with two crosspieces and long ground wire crosspiece: short half cross pieces on the ground wire (2), short half crosspieces on the top crosspiece (2) and long half crosspieces (2)
- > Double-circuit type with two crosspieces and short ground wire crosspiece: short half crosspieces (4) and long half crosspieces (2)
- > Double-circuit type with two crosspieces, without ground wire crosspiece: short half crosspieces (2) and long half crosspieces (2)

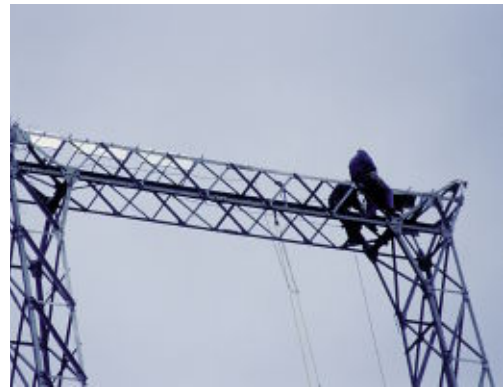
Installing anti-nesting devices

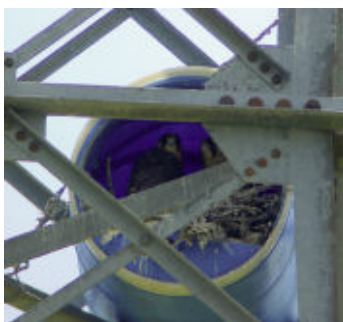
Box-nest occupied by a couple of hawks

The monitoring showed that the preferred height at which the nests were built on the pylons coincided with the height of the first line conductor. It was also observed that the location of the nests on the second crosspiece may vary; it is located less often on the second crosspiece or under the lower crosspiece.

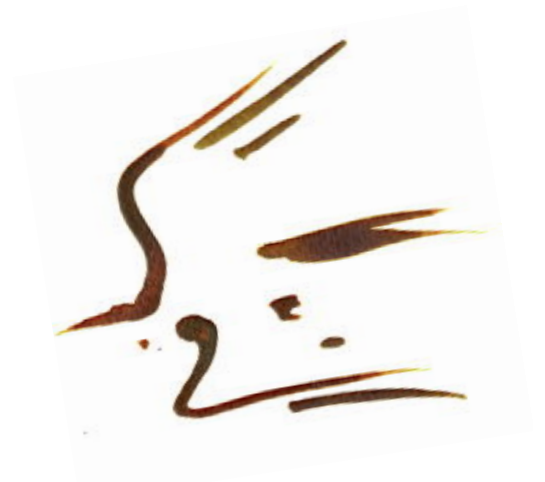
Distribution of the lesser kestrel in the Iberian Peninsula
